# LESSONS FROM SICHUAN EARTHQUAKE: FAILURE AND STRUCTURAL INTEGRITY

**Summary** The Failure was extensive to residential and commercial buildings and lifelines after the 12 May 2008 Sichuan earthquake. This work presents post-earthquake field investigations, features failure modes in the different damaged structures and the cause of the damage to the effects of the loading during the ground motion. It is noticed that structural failure during earthquake is often associated with a small number of post-yield stress reversals and large cyclic deformations with local buckling or plastic damage. It should be considered in seismic Integrity and reliability analyses that focus on very low cycle damage. Finally, the paper briefly discuss the extraneous effects on the mechanisms of very low cycle fatigue, the possible use of collapsed building waste to produce concrete for rebuilding.

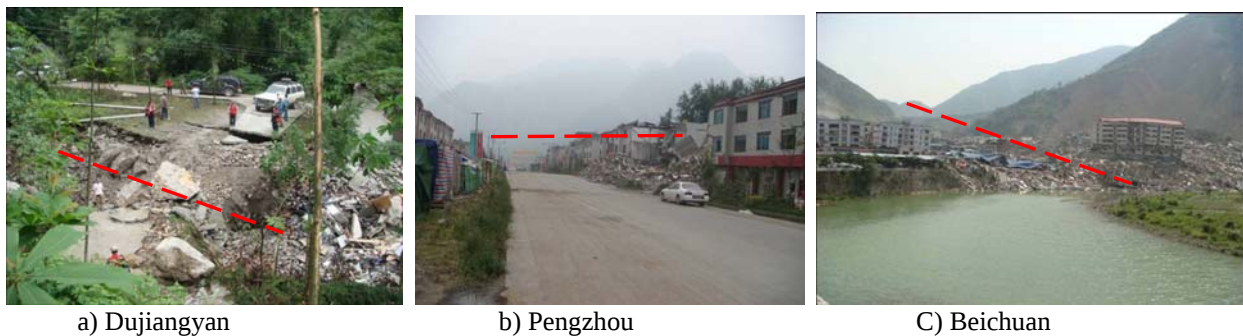
Fig.1 Buildings damaged due to fault propagate

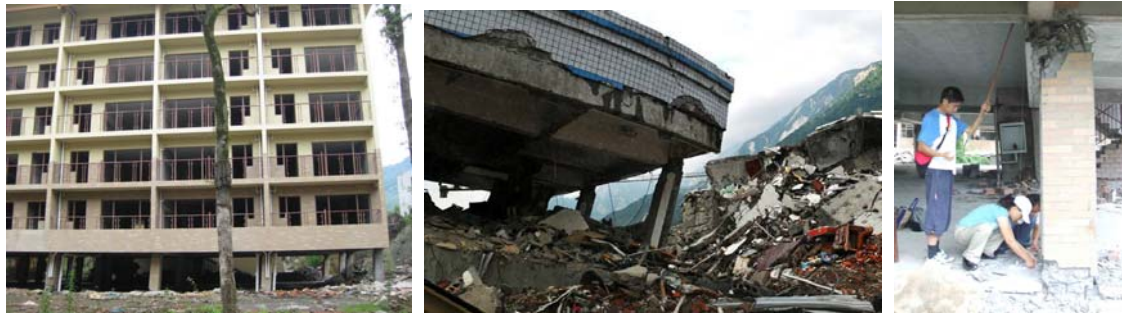
Many residential and commercial buildings in the epicenter area experienced severe damage to the first story. Generally, the ground stories of these buildings were used for commercial space or as parking space, and the upper stories were used as residential apartments. These buildings had less, even no infill walls (or other strong and stiff lateral load resisting elements, e.g. shear walls or strong columns) in the first story to increase the parking or commercial spaces. Such an arrangement of tiles infill walls created stiffness discontinuities in these buildings.

Fig. 4 Soft storey failure

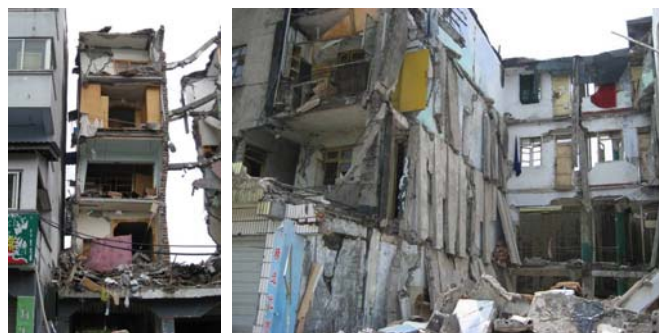
Even badly built buildings can resist some up-and-down loads, not side-to-side loads. The structural elements such as walls, beams and columns that were bearing only vertical loads before the earthquake, have now to carry horizontal bending and shearing effects as well. The principal cause of earthquake-induced failure is ground shaking. As the earth vibrates, all buildings on the ground surface will respond to that vibration or cyclic loading (Fig.5). The earthquake loads are dynamic.

Fig. 5 Failure due to horizontal dynamic loading
