# DAMAGE DEVELOPMENT IN STEELS SUBJECTED TO EXPLOITATION PROCESSES: ATTEMPT TO CORRELATE THE PARAMETERS OF DIFFERENT TESTING TECHNIQUES

**Summary** Development of damage due to creep at elevated temperatures and fatigue at room temperature was assessed for power engineering steels using destructive and non-destructive methods. The experimental programme contained also microscopic observations to find feedback between macro- and micro-scopic parameters. Three different power engineering steels were tested, i.e. 40HNMA, 13HMF and P91.

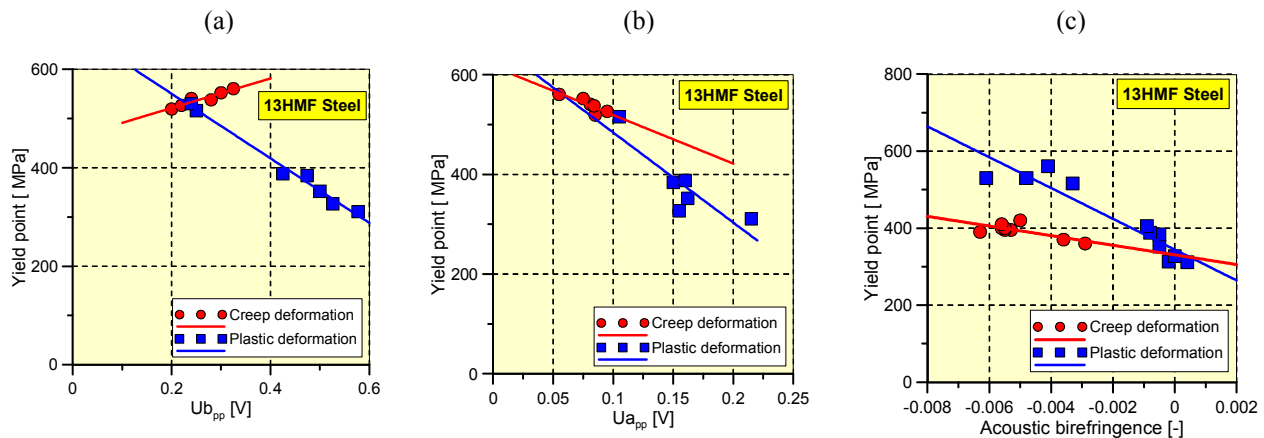
Fig. 1. Illustration of mutual relationships between the yield point and damage sensitive parameters of non-destructive investigations: (a)  $U_{b_{pp}}$  - measure of the HBE; (b)  $U_{a_{pp}}$  - measure of the MAE; (c) acoustic birefringence.

The ultrasonic and magnetic techniques were used as the non-destructive methods for damage evaluation. The results indicate that the acoustic birefringence,  $U_{b_{pp}}$  - measure of the HBE and  $U_{a_{pp}}$  - measure of the MAE are sensitive to the amount of prior deformation. Having parameters of destructive and non-destructive methods of damage assessments their mutual relationships were considered in order to find their character. The representative results are presented in Fig.1 for the 13HMF steel. In the same way the results for P91 and 40HNMA steels were elaborated.

The results exhibited that magnetic techniques can be very sensitive to degradation development for the small strain levels (up to 2%), and almost insensitive above that value. The ultrasonic techniques gave a completely opposite assessment: very poor sensitivity for small deformations and good for deformations greater than 2%. Hence, it seems to be reasonable to use them together: in the first period of operation - magnetic methods, in the subsequent stages – ultrasonic ones.

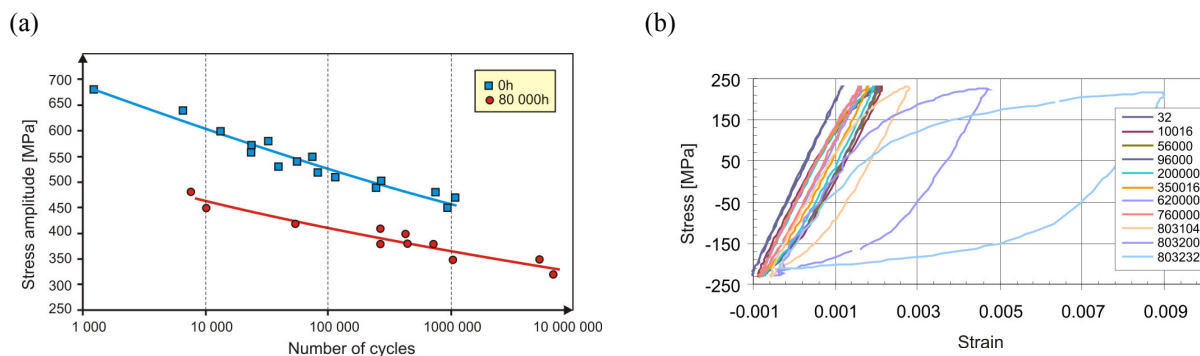
Fig. 2. Representative results of fatigue tests for the 13HMF steel: (a) the Wöhler characteristics for the material in the as-received state and after exploitation; (b) strain evolution during fatigue under stress amplitude of 230 MPa.

In the case of material prestrained due to fatigue the destructive tests gave no clear assessment of material degradation, because the basic mechanical parameters (i.e. yield point and ultimate tensile stress) underwent increased. Therefore, in order to assess a degree of fatigue damage the alternative techniques were proposed. The Wöhler diagram was determined as the first step of fatigue tests on the 13HMF and P91 steels. It represents the number of cycles necessary to failure under given stress amplitude. In the case of 13HMF steel this curve was determined for the material in the as-received state and after exploitation (80 000h), Fig.2a. As it is seen, these curves differ significantly, identifying the

fatigue strength reduction due to the loading history applied. In addition, investigations were performed in which variations of the hysteresis loop width were evaluated under constant stress amplitude.

These studies have shown that this type of procedure gives an opportunity to assess a supply of the safe operation period of the material, and there is no need for so many experiments, as this is required for the Wöhler diagram determination. Moreover, an identification of damage measures was carried out. The behaviour of metals under fatigue, can be divided into two basic types of mechanisms in terms of the damage development [3]. The first group is described by the ratcheting (a shift of the hysteresis loop as a result of the strain mean level increase), generated by local deformation around the voids, non-metallic inclusions and other defects in the microstructure, whereas the second one by cyclic plasticity (a gradual increase of the hysteresis loop width) generated at the local level grains by dislocation motion and slip bands. In both cases, the strain changes measured for the entire sample volume are the sum of local deformations developing around defects in the form of non-metallic inclusions and voids (first group) or developing slips within individual grains (second group). Both fatigue damage measures are well presented in Fig. 2b.
